ARBORIST REPORT

LOCATION: 2 Station Road Ave. Toronto

SUMMARY: Removal of one Silver Maple @ Mimico Ave., removal of West property line trees affecting construction; Protection of 3 trees along Station Rd.and Maple fronting Mimico Ave.

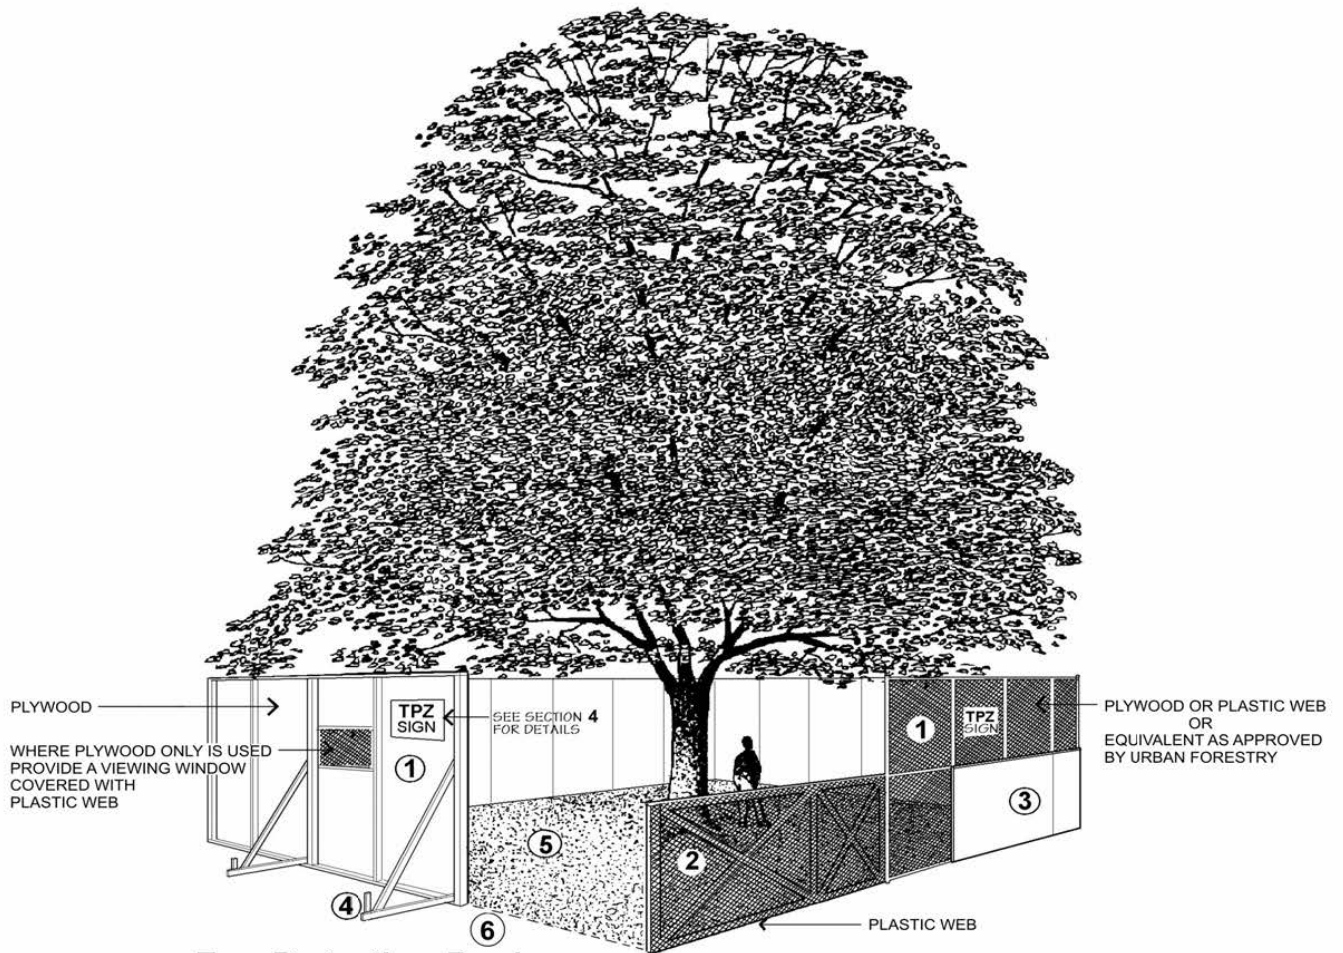
See Tree Protection Plan.

Tree Inventory: Tree locations and protection zones shown on attached T-1 Protection Plan 03/14/2013

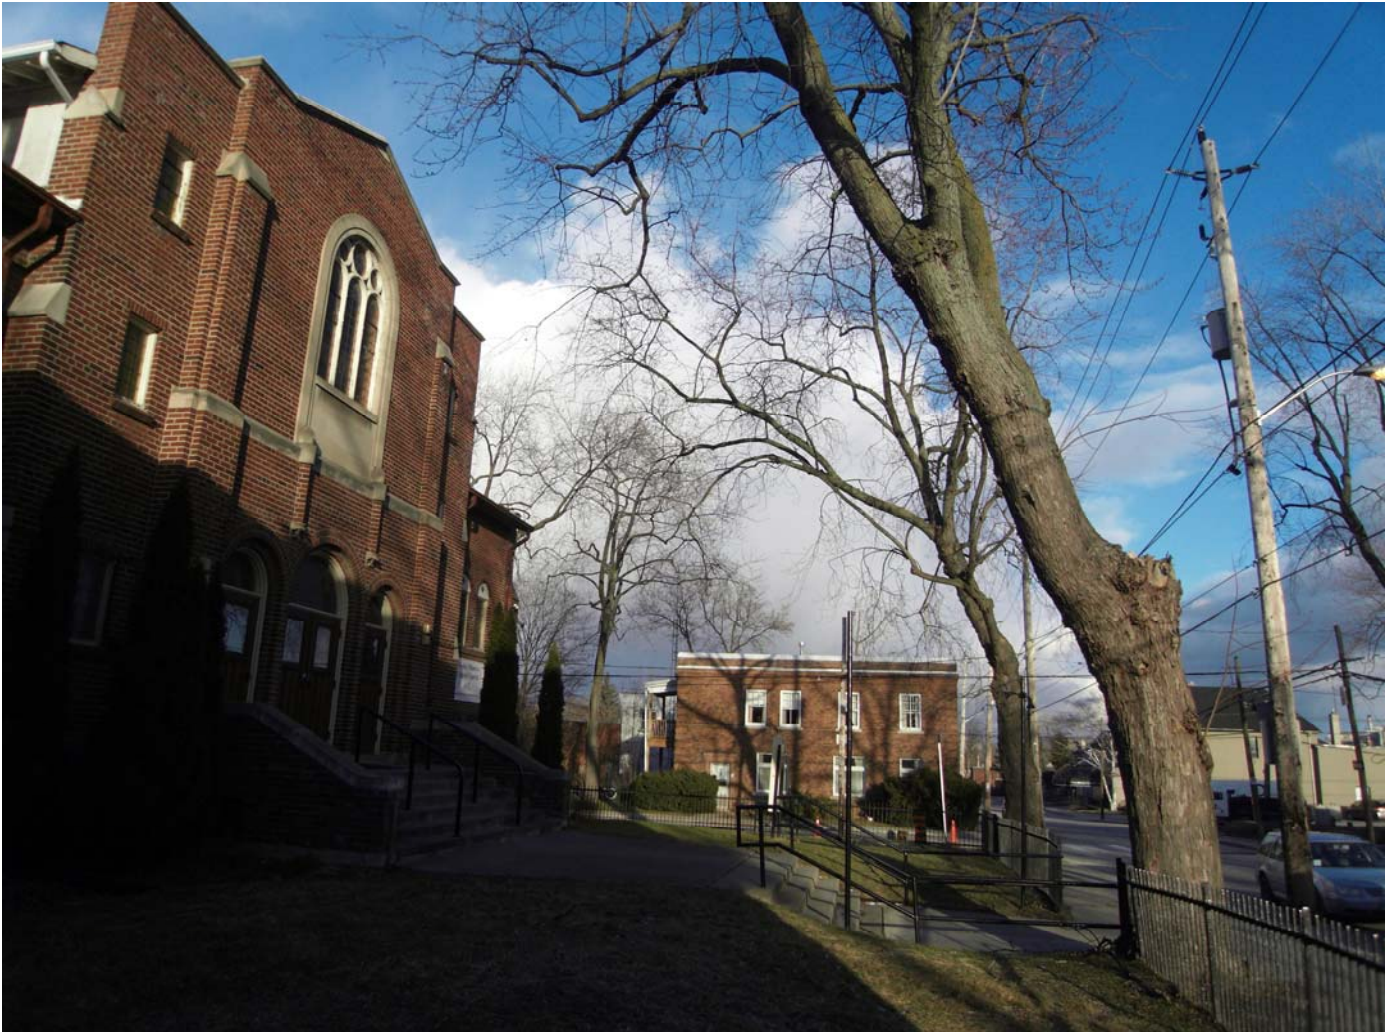
Tree	Species	DB H cm	Condition & Assessment
T1	Acer saccharinum Silver Maple	85	Remove - Below Acceptable condition. The Acer saccharum T-1 facing Mimico Ave. is infected with advanced Mushroom growth in a large open wound from a major branch that broke off within the past 2 years at a height of 4.5 metres. The presence of mushroom so recent to this branch removal indicates internal weakness of the wood. (see photo) The upper branching form leans toward the church building and will be affected by construction and require limb removal. The heavy lean of the top weight in one direction will pose a wind-blown hazard in extreme weather. There are some signs of perennial frost crack in the trunk bark. Crown growth is good but areas of suckering also present. Suckering will create unstable branching form over time. This is typical of soft wooded trees such as silver maple that become liabilities in later age. Given the age of the tree- 80+ years, and species – Silver Maple, removal and replacement with a harder wood tree species with strong leader form and long-lived is highly recommended. The tree could live for another 5 years before becoming a hazard. However, given the proposed building additions and the chances of survival after construction, replacement trees as compensation for the existing Maple are a better option for the site and local context. The landscape plan should include a quantity of more desirable, long lived species with stronger wood as replacements.

Photo 1 - Mimico Ave, Silver Maple with all weight leaning to building. Formerly double leader. One leader facing overhead wires detached in wind storm previous year. This tree is becoming a hazard and is best replaced. Silver Maple in background has kept better form and health condition and should be retained. **Photo 2** below : Mushroom growth in large wound of Silver Maple Foreground.

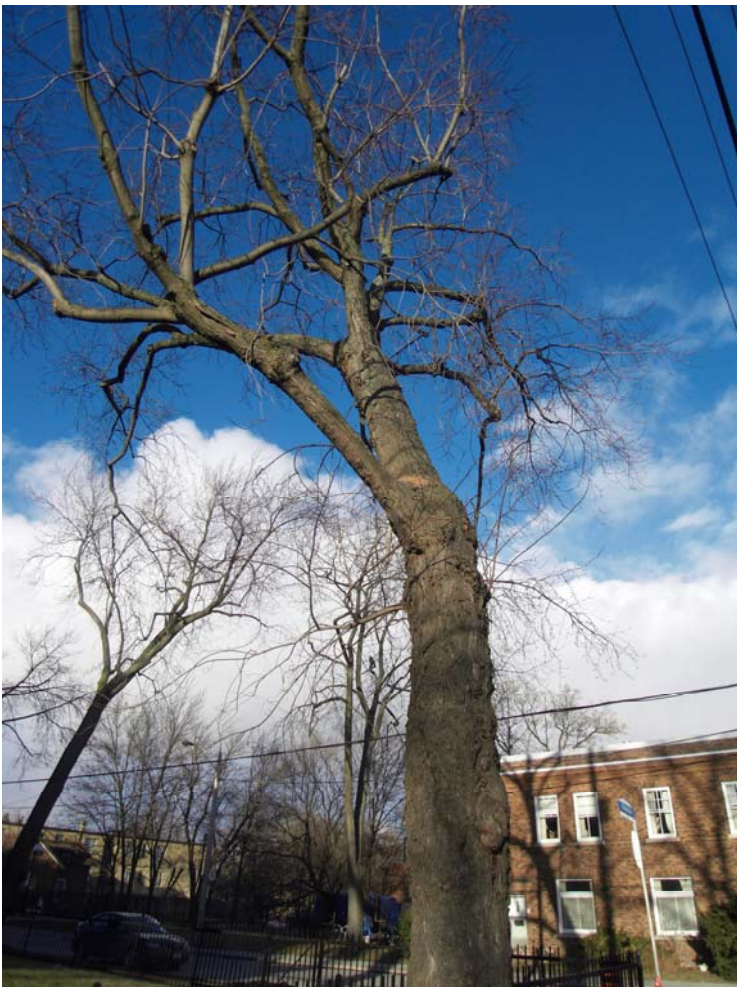
Photo 3 - Mimico Ave, Silver Maple with most weight leaning to building. Still strong form. Good condition; Roots impacted by proposed expansion. Oak in background in good form and health condition and should be retained. **Photo 4**- Station Road, Silver Maple in background, acceptable but lower injury. Oaks in foreground have strong form. Good condition; Roots impacted by proposed expansion.

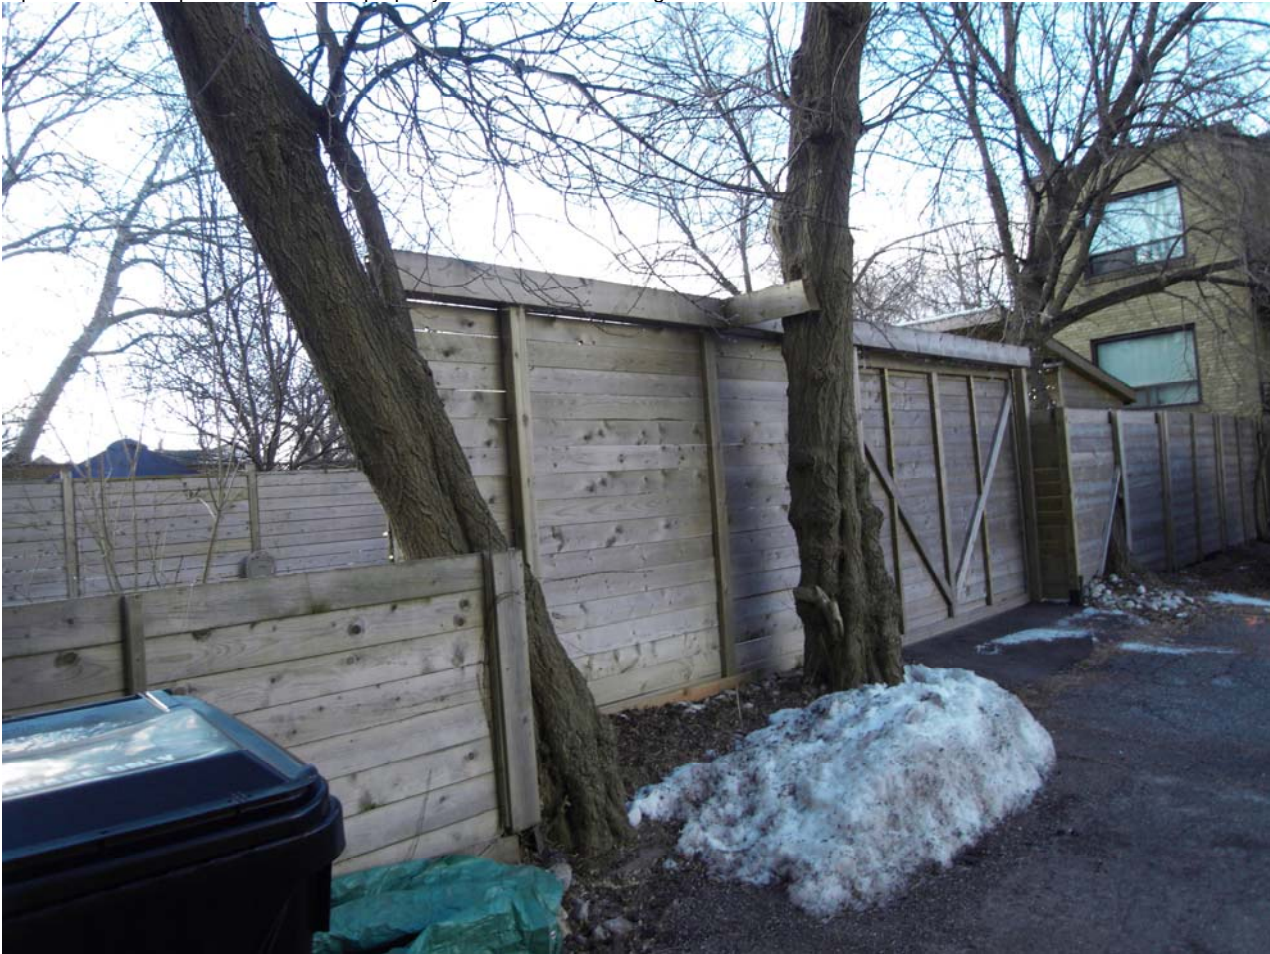
T7	Fraxinus pensylvanica Red Ash	45	Remove Good Condition. Leaning over neighbour property. For soil removal of exposed roots. After soil is cleanly removed by compressed air, Arborist will cleanly root prune by saw, pruners and dress with alcohol and optional shellac seal. Excavation for water proofing. Typical.
T8	Fraxinus pensylvanica Red Ash	38	Remove Fair Condition. Leaning over neighbour property. Impacted by new addition and waterproofing requirements. Replace with multiple additional trees in landscape plan away from property line.
T9	Fraxinus pensylvanica Red Ash	32	Remove Fair Condition Leaning over neighbour property. Impacted by new addition and waterproofing requirements. Replace with multiple additional trees in landscape plan away from property line.
T10	Fraxinus pensylvanica Red Ash	38	Remove Fair Condition. Leaning over neighbour property. Impacted by new addition and waterproofing requirements. Replace with multiple additional trees in landscape plan away from property line.

Photo 5 - Station Road , Silver Maple with branching away from building. Double leader. One leader facing overhead wires. Has good form and overall health condition and should be retained. **Photo 6** rear west property line: Red Ash . heavy leaning marginal form. No serious health conditions but bad placement, tree form that will create a hazard in the future. Not critical to remove. However, replacement trees in quantities to match value of existing trees will serve the site and the neighbour better. Removal will also facilitate excavation for water-proofing. Recommend replacement trees placed further from property line than these existing trees.

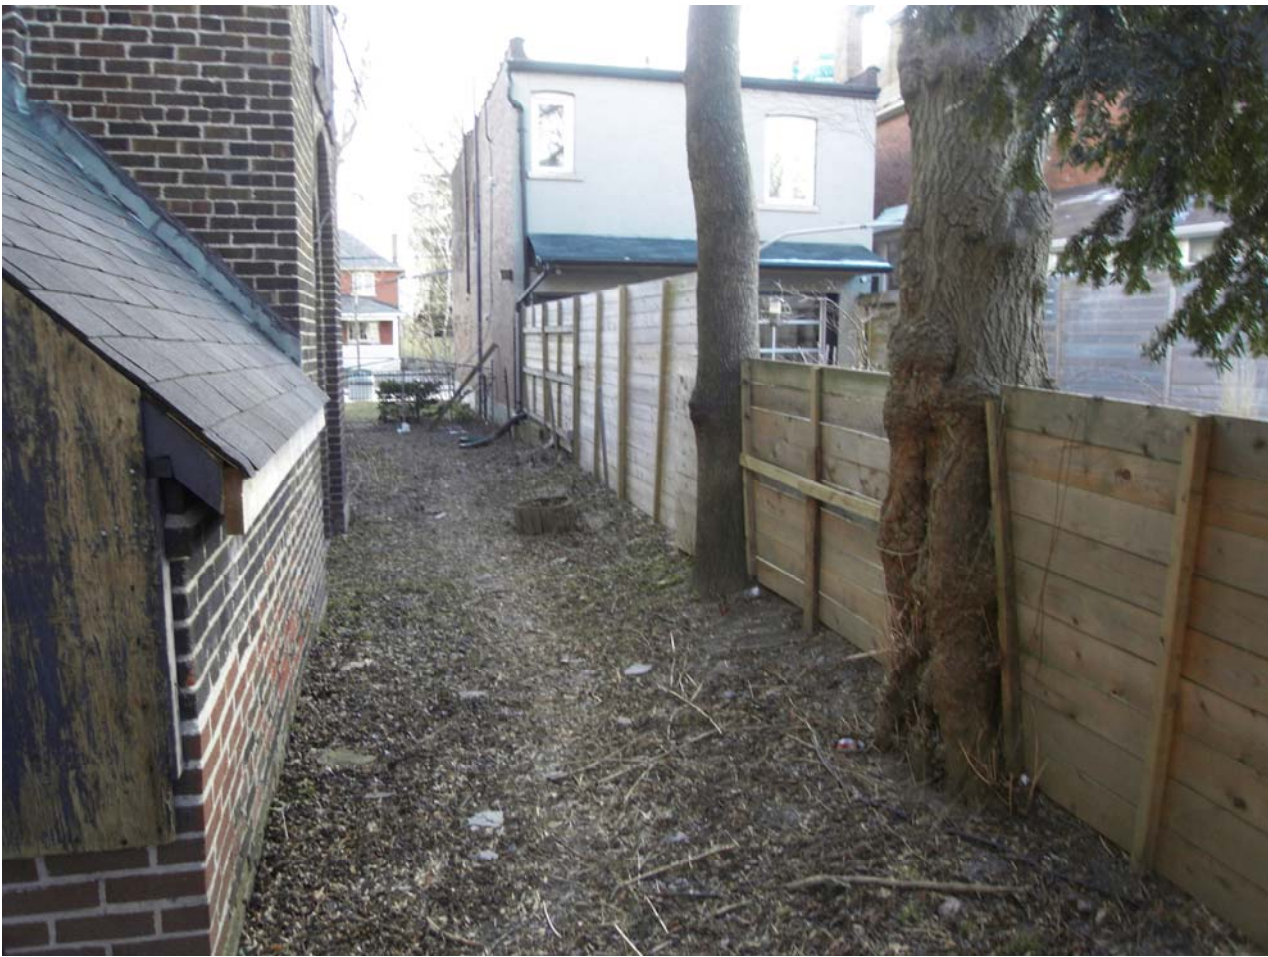
Photo 7- West property line: White ash and Red ash with strong upright form. Propose to replace with more desirable tree species in this zone away from property line. Access walkway to hug the building to create acceptable planting bed space along the property line.

The removal of west property line trees will be compensated with additional desirable species trees as part of the landscape plan to replace these west boundary trees and located new them in a more logical location offset from the property line. The proposed west property line access path will hug the building in order to create space for these replacement trees
